**DEPARTMENT OF TRANSPORTATION****DIVISION OF ENGINEERING SERVICES**

Contract #: 04-0120F4Cty: SF/ALA Rte: 80 PM: 13.2/13.9File #: 99.28**WELDING INSPECTION REPORT****Resident Engineer:** Pursell, Gary**Address:** 333 Burma Road**City:** Oakland, CA 94607**Report No:** WIR-001818**Date Inspected:** 24-Mar-2008**Project Name:** SAS Superstructure**OSM Arrival Time:** 830**Prime Contractor:** American Bridge/Fluor Enterprises, a JV**OSM Departure Time:** 1930**Contractor:** Japan Steel Works, Ltd.**Location:** Muroran, Japan

## WELDING INSPECTION REPORT

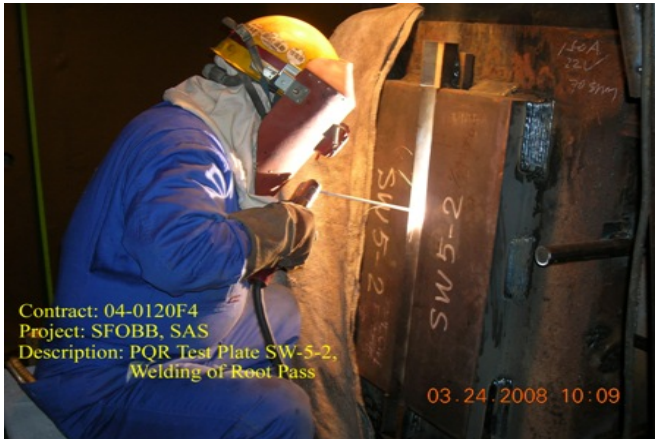
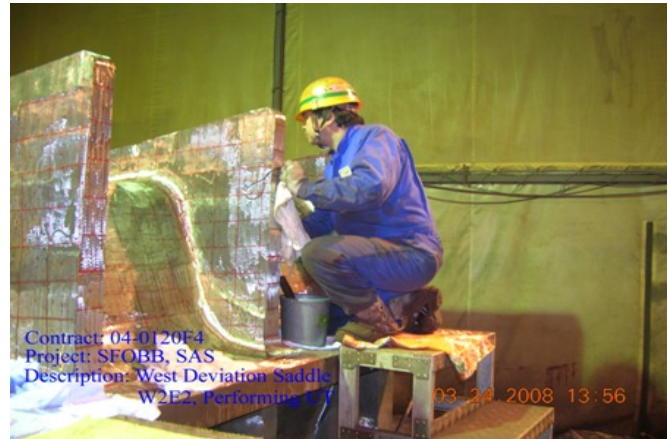
Later in the shift this QA inspector observed the ultrasonic testing of the West Deviation Saddle performed by JSW technicians Harumi Kohama and Atsusi Seino. Mr. Harumi Kohama and Mr. Atsusi Seino utilized the straight beam method and the ultrasonic instrument identified as a Krautkramer USM35. The ultrasonic testing was not completed during this shift on this date and appeared to comply with the contract documents. (See Digital Photographs)
